# Service Information

Category <b>S</b>	<b>Repair Guidance</b>	Ref. No. R048/16A	Page 1 of 2
Coverage <input type="checkbox"/> Distributor only <input checked="" type="checkbox"/> Please inform your dealers		Date Issued May 30, 2016	
Please convey this information to your <input type="checkbox"/> Director <input checked="" type="checkbox"/> General Manager <input checked="" type="checkbox"/> Warranty Dept. <input checked="" type="checkbox"/> Parts Dept. <input checked="" type="checkbox"/> Training Dept. <input checked="" type="checkbox"/> Field Rep.		Date Revised June 7, 2016	
Applicable Model  MX-5 (ND) without INNER CLOTH	Applicable Countries or Specifications  Worldwide

## Subject: Rubbing/Contact Marks on CONVERTIBLE TOP (Top Fabric)

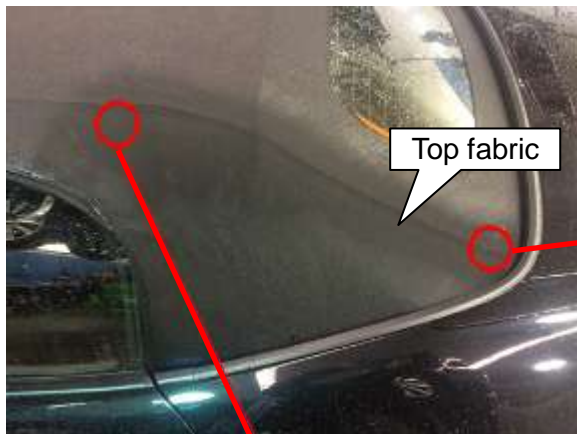
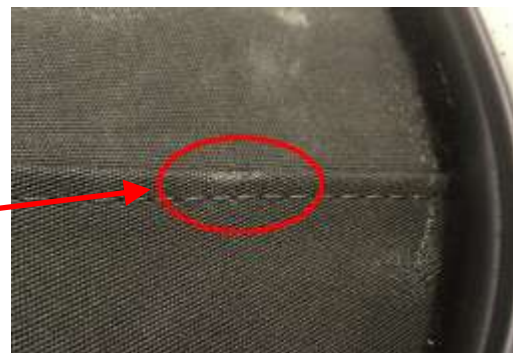
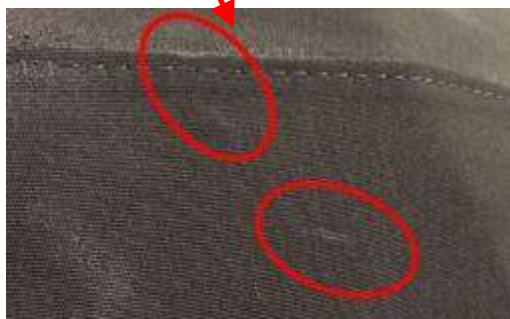
Some vehicles may exhibit rubbing/contact marks on the top fabric of convertible top around the area shown in figure below. Marks may occur on the right and/or left side(s).

**NOTE:** Pictures show the left side.

While the vehicle is running with the convertible top opened, the top fabric, being folded and piled up, receives vibration and the stitching line (hard) touches top fabric causing rubbing/contact marks.

**NOTE:** Compared with the top fabric with inner cloth, the top fabric without inner cloth has a disadvantage against occurrence of this concern because the folded height is set lower and so the top fabric is folded and piled up in more tight condition.

The link stopper of convertible top has been changed to adjust the opening angle of the convertible top, thereby decreasing the contact pressure applied to the top fabric when folded and piled up.

When you receive a customer complaint on this concern, replace the convertible top assembly with the modified one according to the procedure in the workshop manual “**CONVERTIBLE TOP REMOVAL/INSTALLATION**”.

**NOTE:** Please explain to the customer that by installing the modified convertible top assembly, rubbing/contact marks will be less likely to occur. However, from its structural reason of the fabric top being folded and piled up, it is impossible to prevent it completely and it may recur depending on the vehicle usage condition.
